# Landslide Hazards in Metropolitan Phoenix

Ryan Cleary, Decision Center for a Desert City, Arizona State University

Where in the Phoenix Metropolitan Area are landslide hazards present and how can damage to residential areas be mitigated?

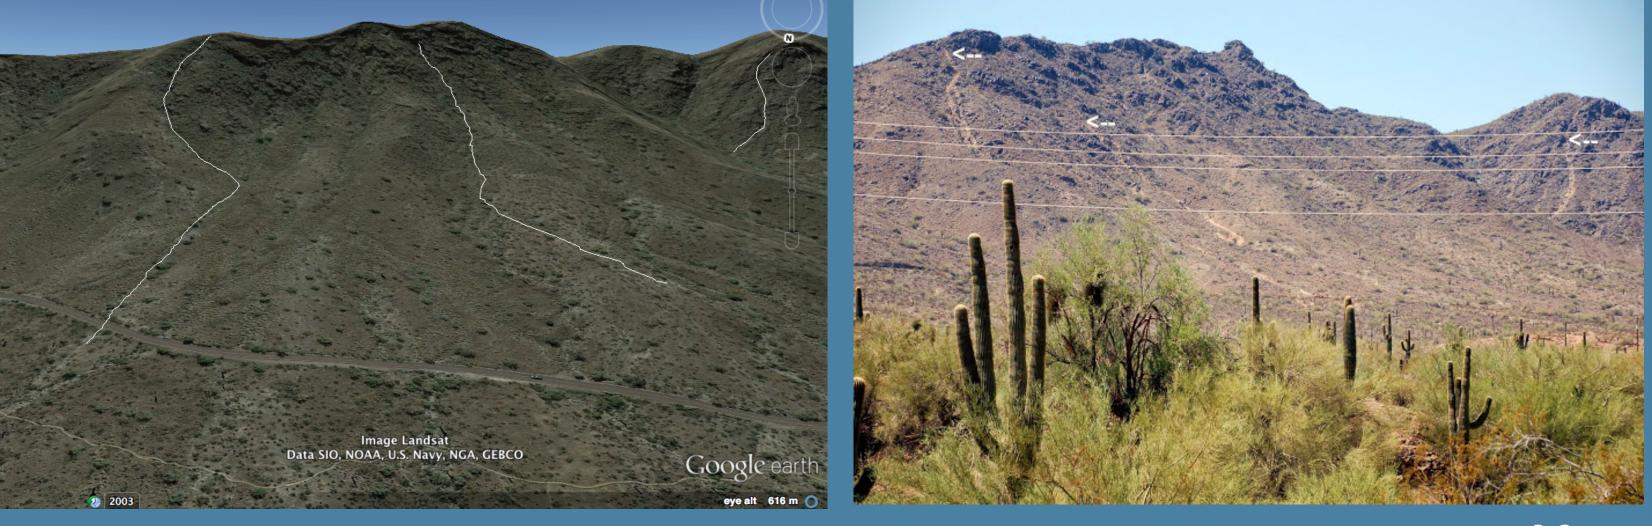
Before

Heavy monsoon precipitation in August and September of 2014 activated debris flow chutes on ranges in South Mountain. The images below show debris flow chutes before and after these events.

The evidence from South Mountain shows that heavy precipiation can cause significant movement on debris flow chutes. If similar debris flows had been activated on slopes that are near residences, significant damage may be possible.
