## Introduction

## Study site and timeframe

Three historic photographs, 1890, 1900, and 1931, captured a view of the Salt River northwest of Hayden Butte from approximately the same orientation and elevation.

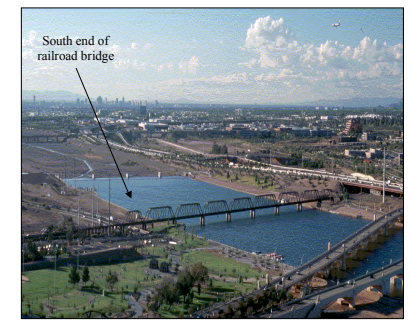
## 2000

This modern view reflects the impacts of urbanization on the Salt River during a period of rapid growth. In 1998, the city of Tempe constructed Tempe Town Lake to stimulate economic growth. The river is entirely channelized and native vegetation is minimal.
