Factors Controlling Invasive Mussel Distribution in Arizona

Andrew Buell, Matthew Sokolowski and Professor Peter Fox, PhD
Arizona State University, School of Sustainable Engineering and the Built Environment

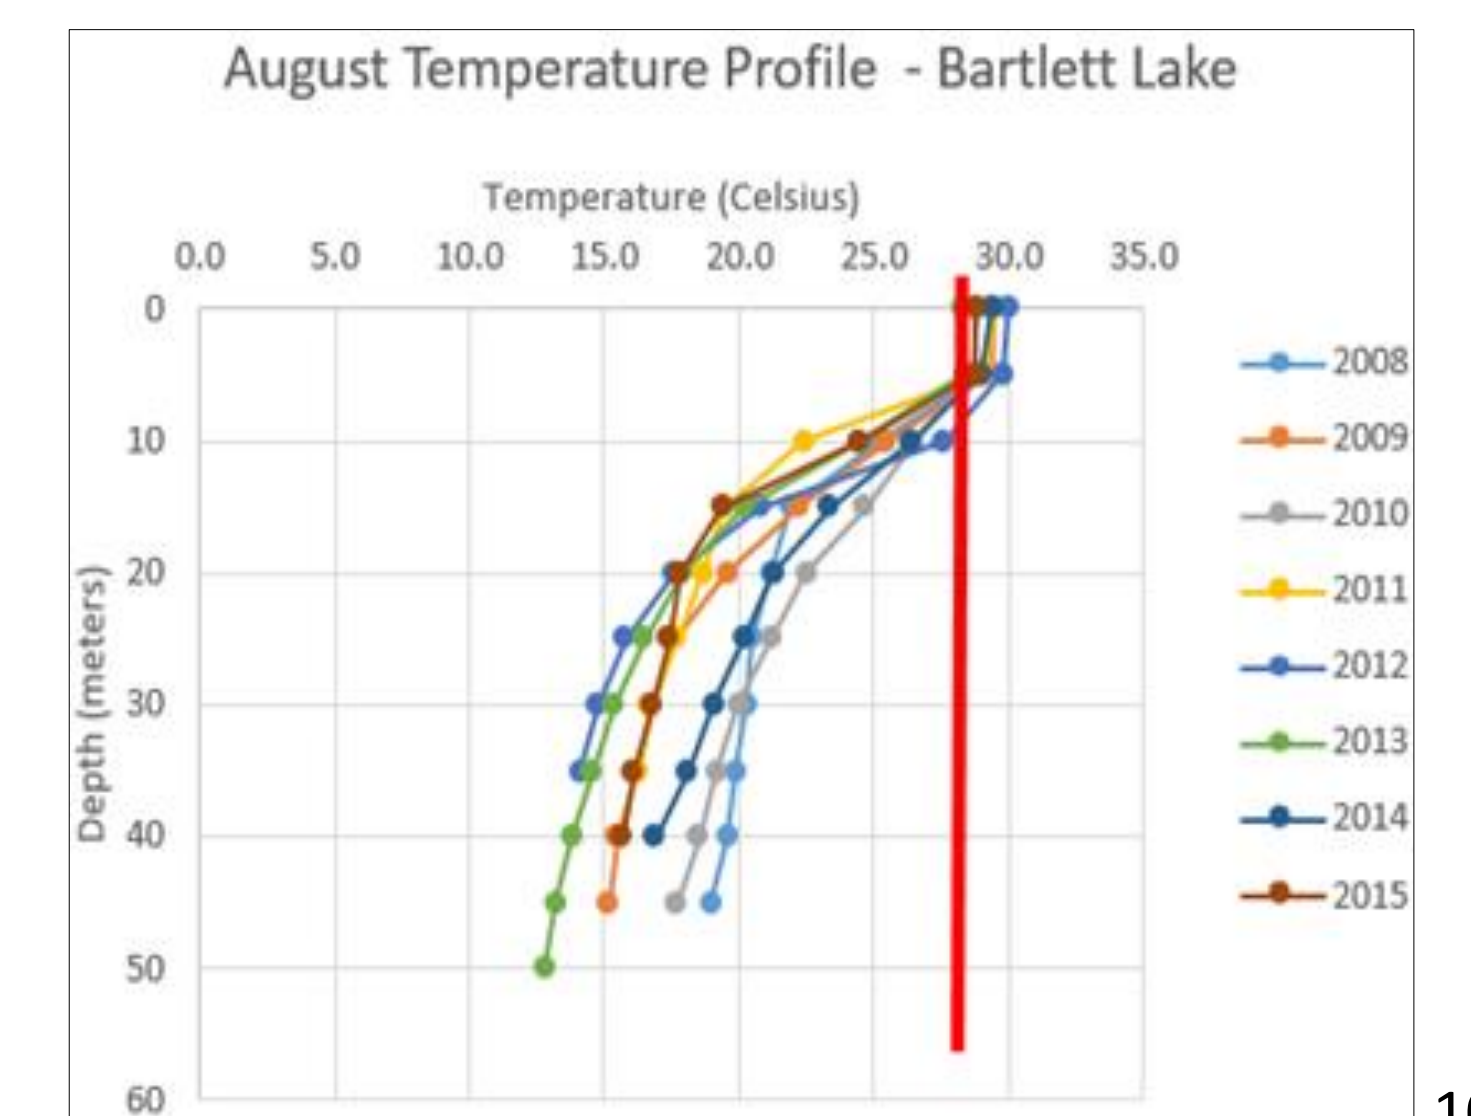
10

- A correlation between survival and the temperature and DO profiles of non infested lakes suggests that during spawning months there are two conditions necessary for survival which are not met.
- Calanoid copepod predation has been ruled out as a factor as none were located in non infested waters yet were identified in infested waters.
- Water chemistry and turbidity have been ruled out due to laboratory testing using water from non infested sources as well as the addition of simulated turbidity. Both of these parameters yielded a 98% survival rate among adult *D. bugensis* specimens.¹⁰
