# Water quality in wetlands along an impervious surface gradient

Stephen Elser<sup>1</sup>, Elizabeth Cook<sup>2</sup>, Olga Barbosa<sup>3</sup>, Nancy Grimm<sup>1</sup>

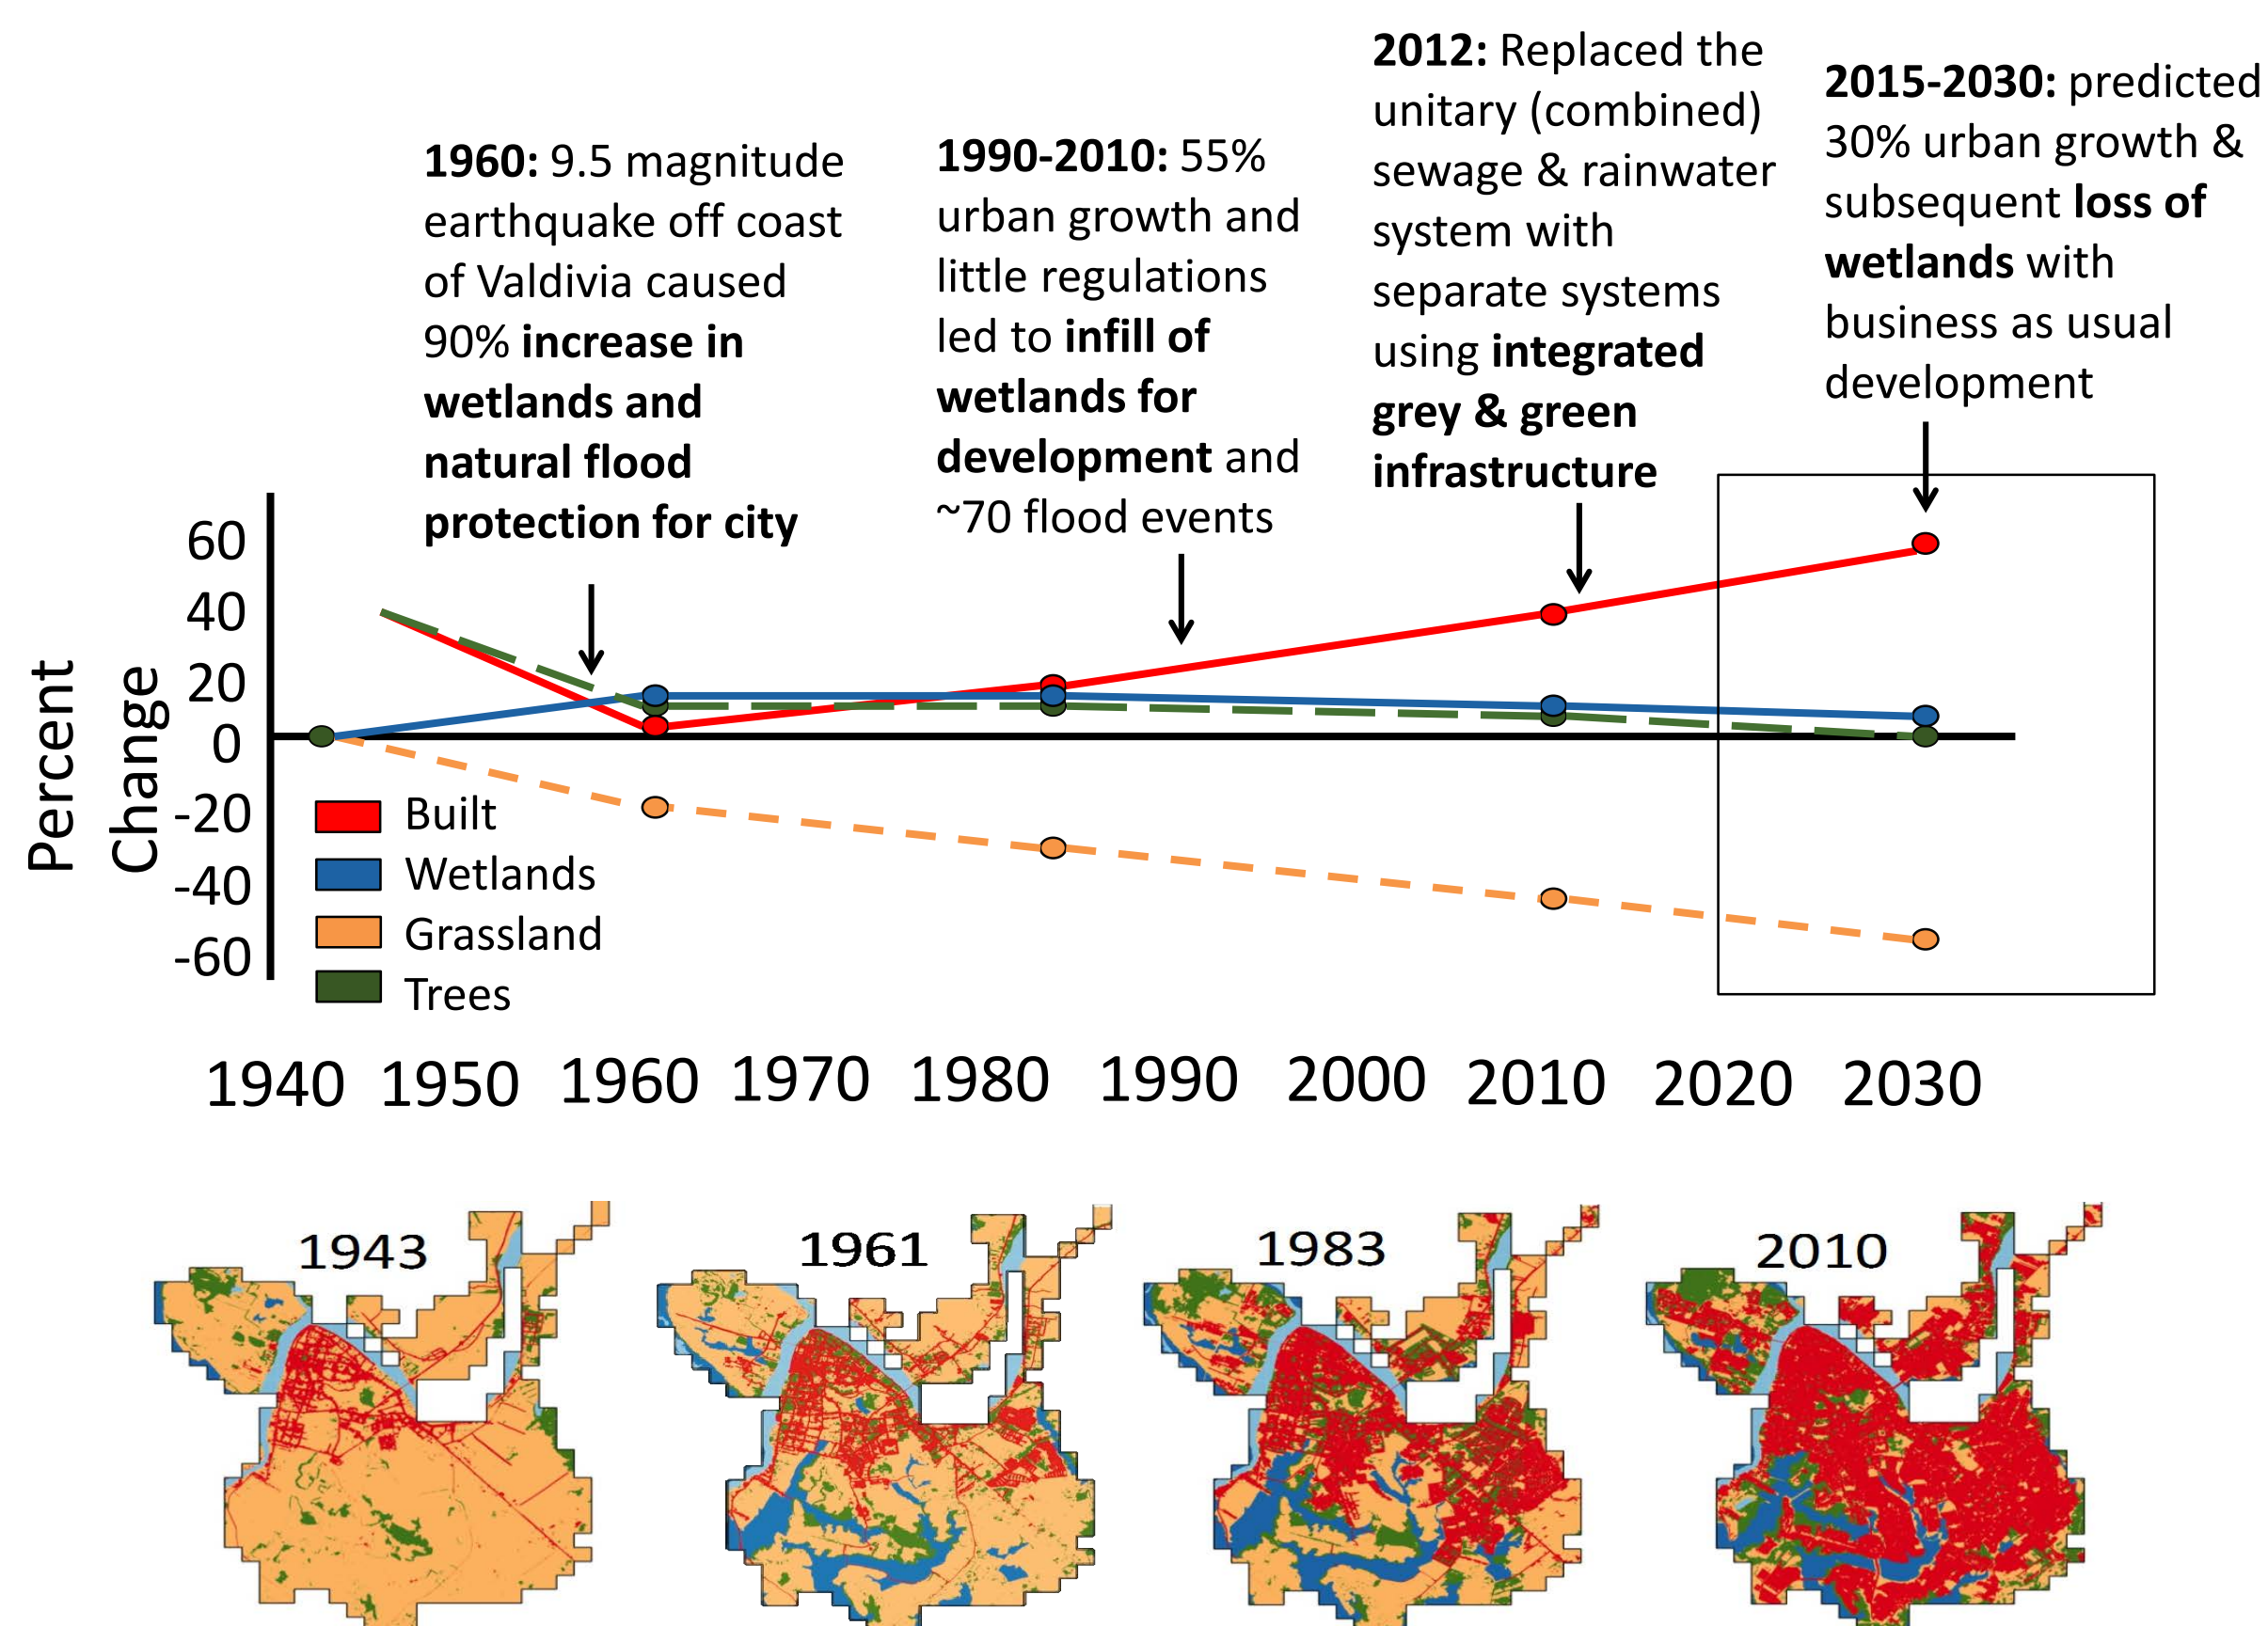
**Figure 1:** After a significant increase in wetlands following the 1960 9.5 magnitude earthquake, rapid urbanization and lack of development regulations led to the infill and decline of natural wetlands in the city. Historically, wetlands were valued more as cheap land for development and waste disposal than for their ecological value. Recently, however, wetlands have been acknowledged in planning documents as valuable flood protection.

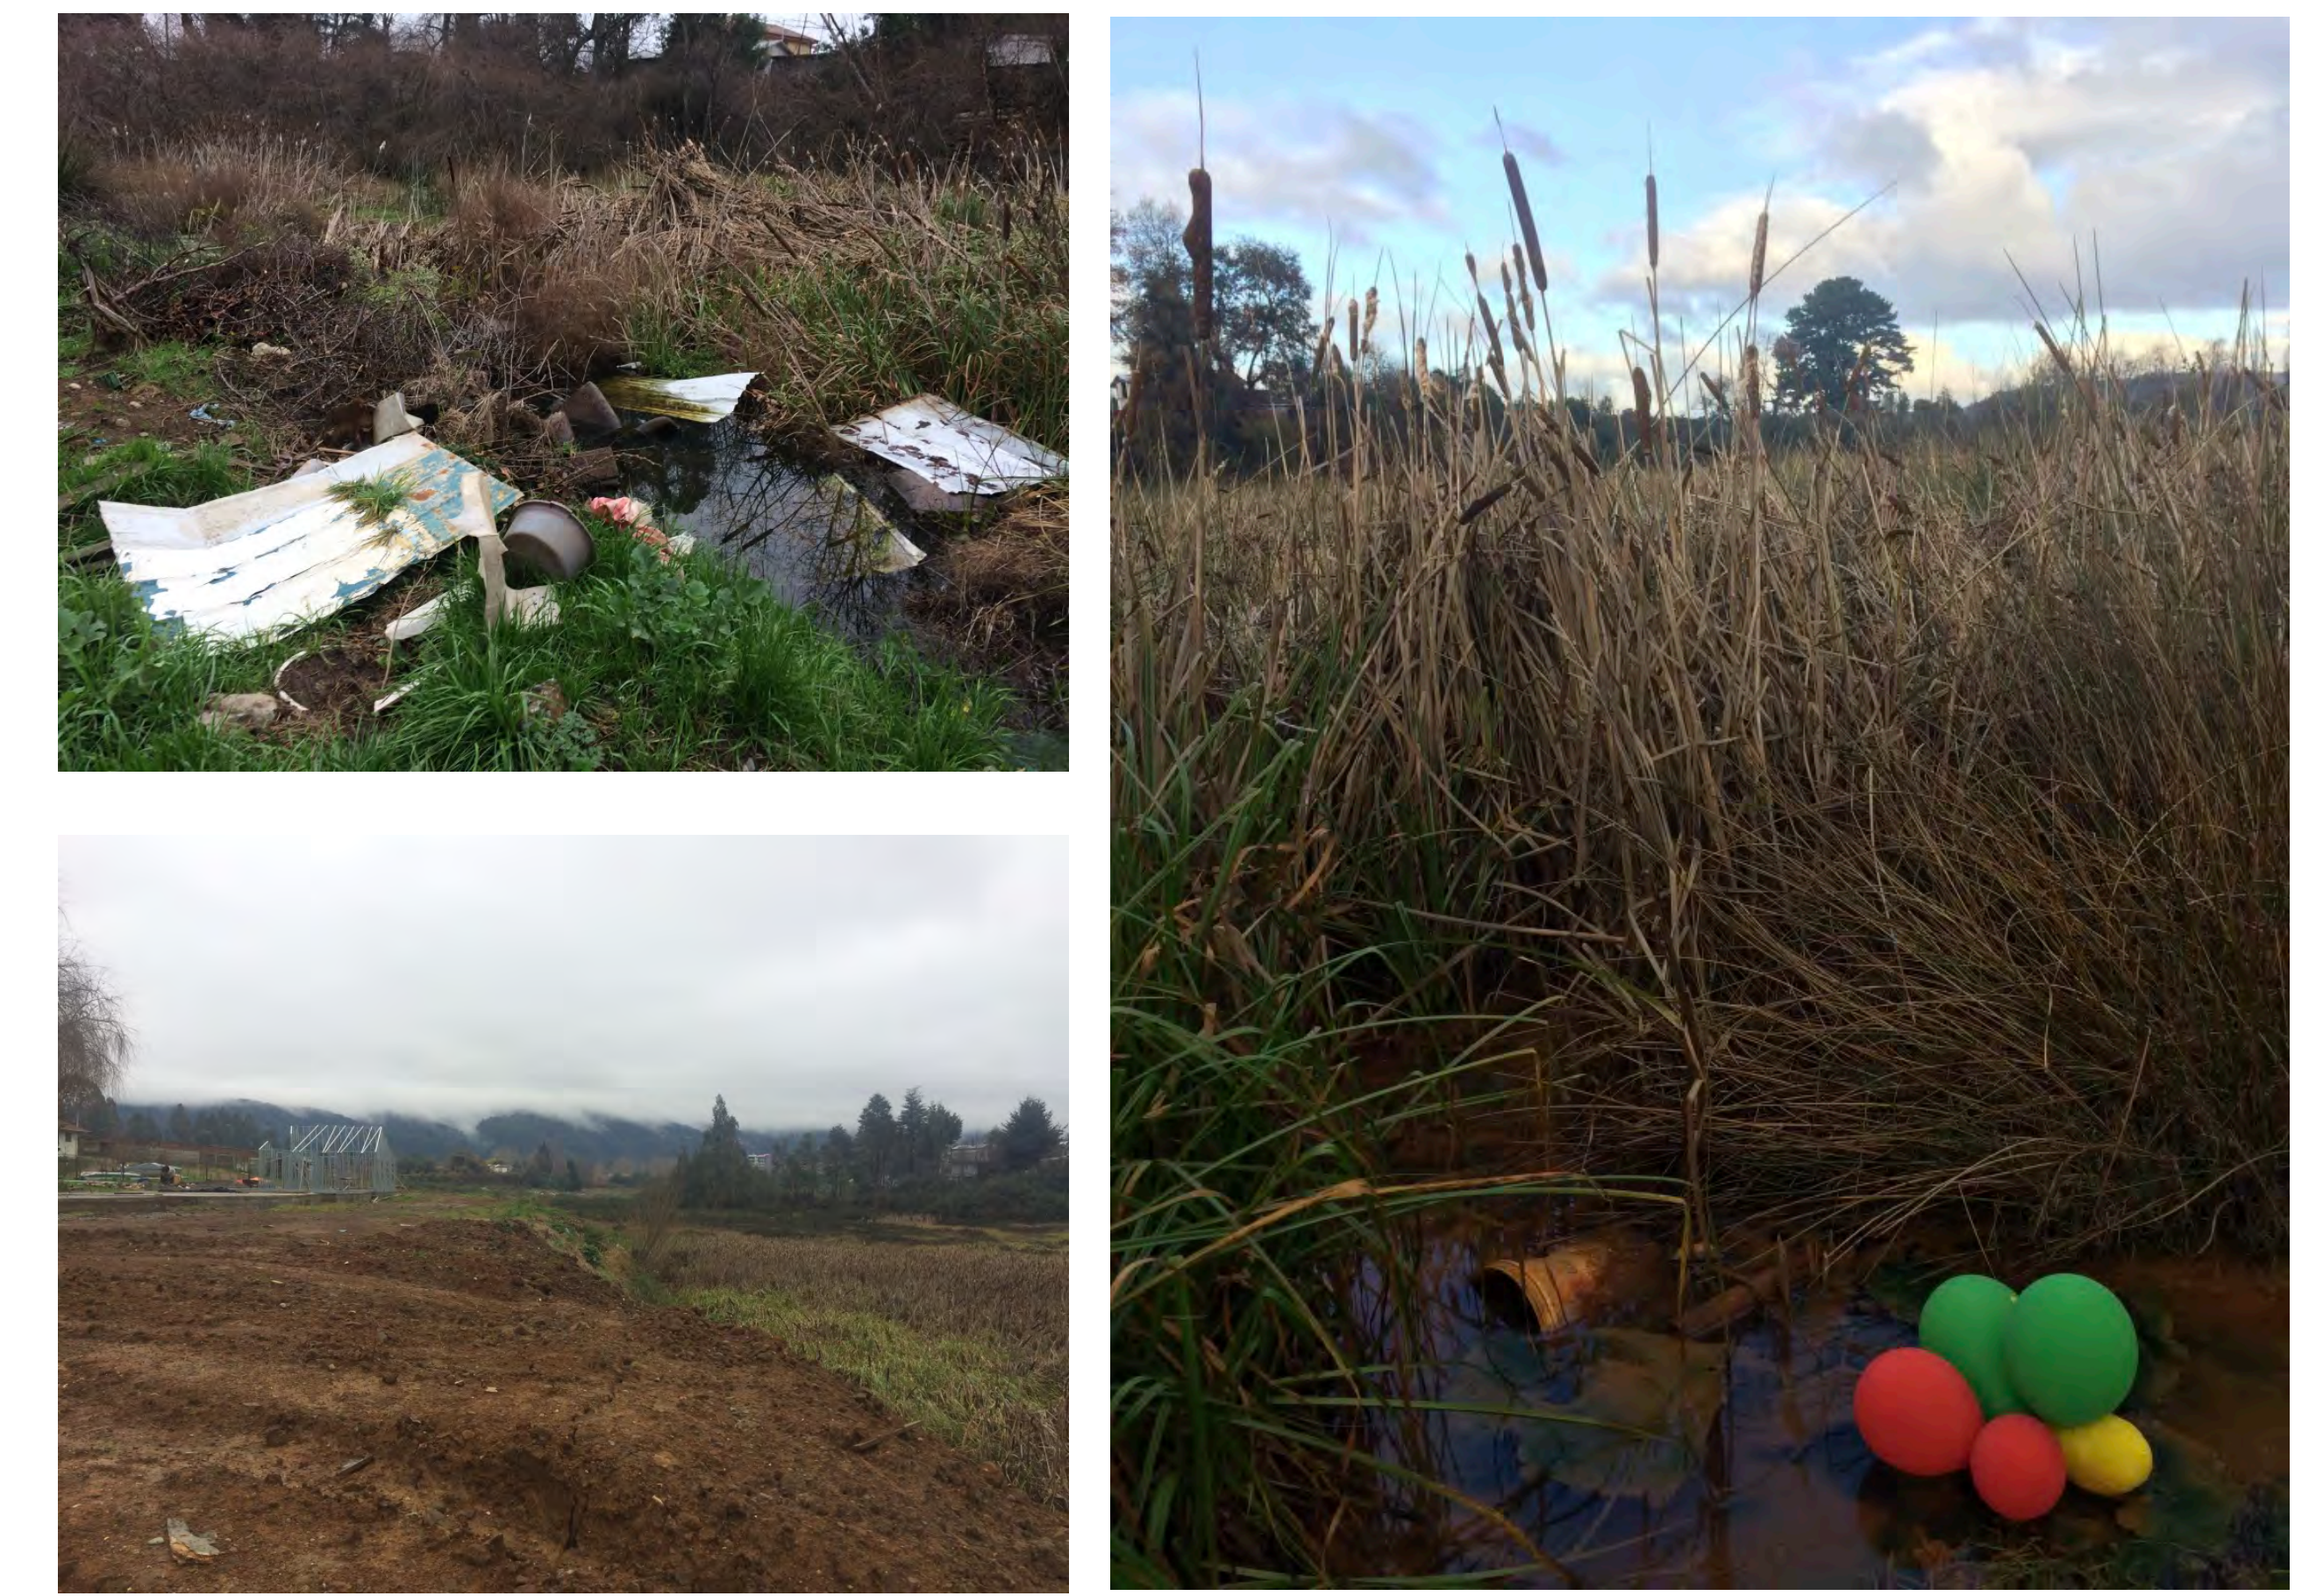
Some photographs from the field. To the right and top left, you can see trash left in the wetlands. This is fairly common to see along the edges of the wetlands, especially in locations with heavy traffic. Though, some fairly remote sites were clearly used as dumping grounds where individuals must have driven their waste to the site in order to dispose of it. In the bottom left, you can see a new housing development encroaching on a, now, partially infilled wetland.
